TAMU Project

**Energy Consumption Data Quality Assurance/Quality
Control Assessment Report for the
Month of January 2016**

**Utility & Energy Services
Division of Administration
Texas A&M University**

February 2016

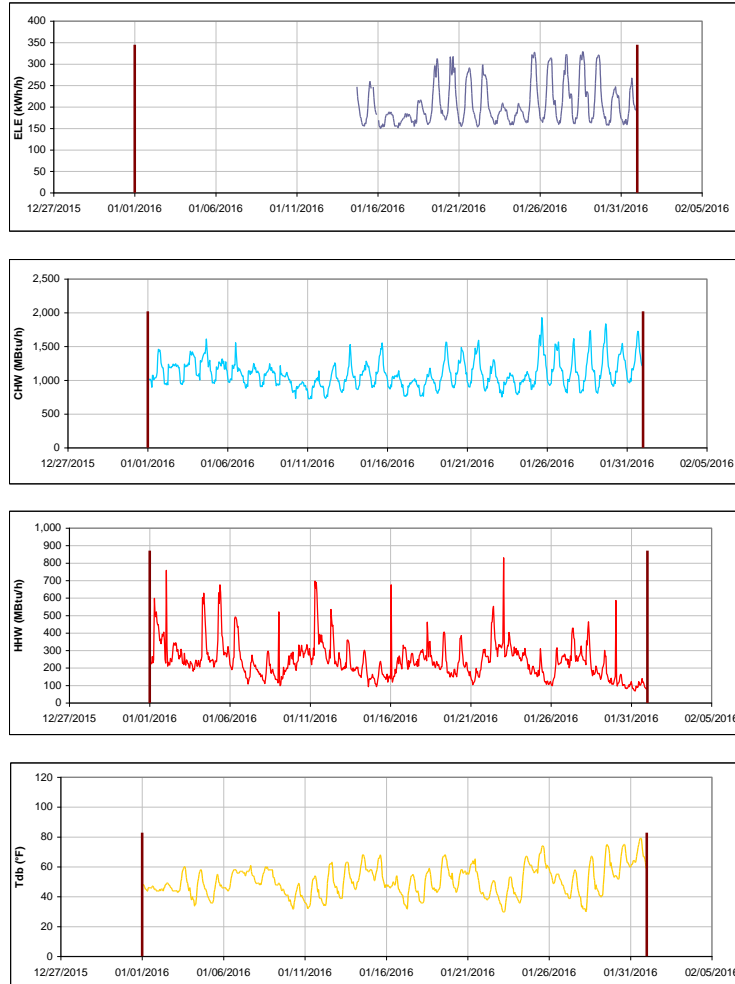
TAMU / BLDG #: 0353

Figure III-9 Hourly Whole Building Electricity, Chilled Water, and Hot Water Consumption for Bright Aerospace Building during the Month of January 2016 and the Corresponding Hourly Outdoor Dry Bulb Temperature for College Station, TX

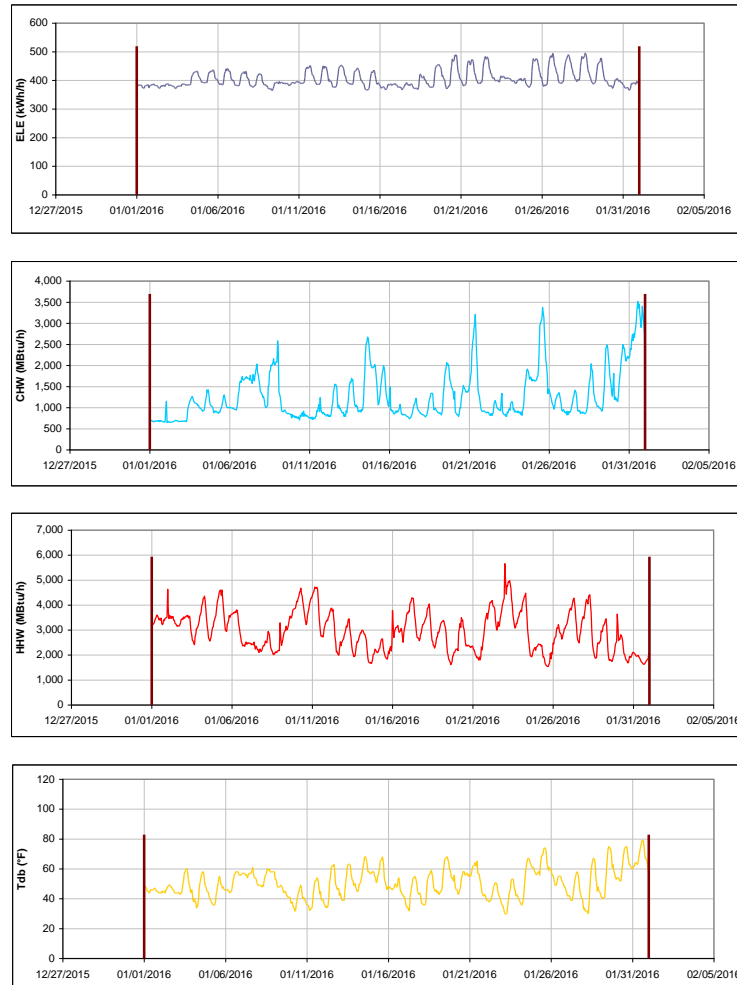
TAMU / BLDG #: 0376

Figure III-15 Hourly Whole Building Electricity, Chilled Water, and Hot Water Consumption for Chemistry Building Addition during the Month of January 2016 and the Corresponding Hourly Outdoor Dry Bulb Temperature for College Station, TX

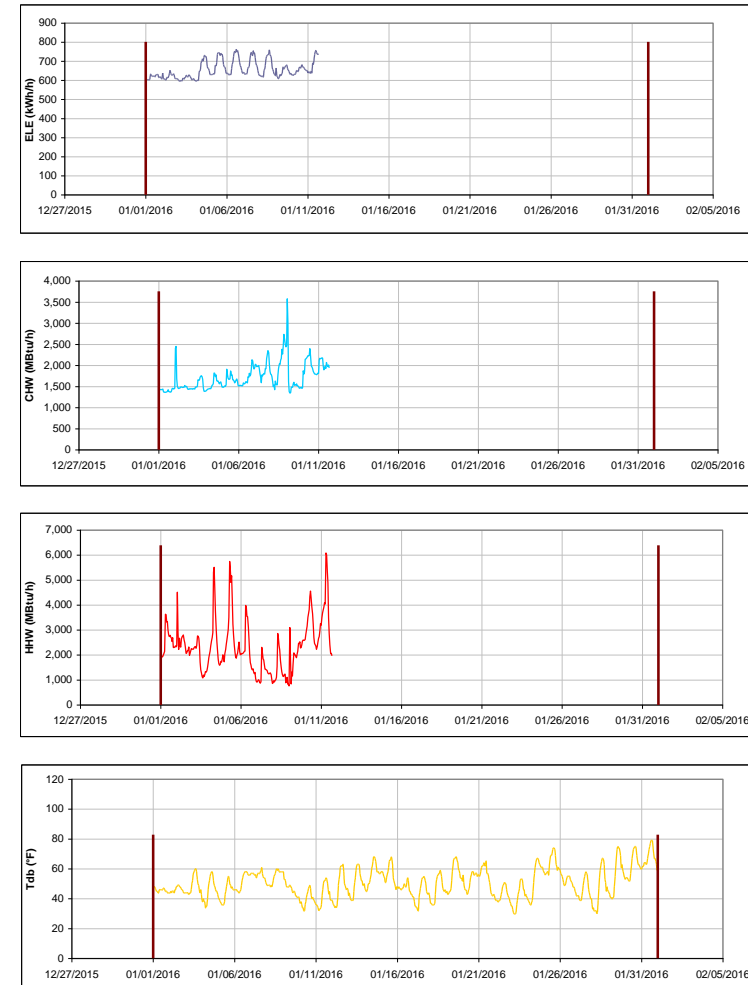
TAMU / BLDG #: 0386

Figure III-20 Hourly Whole Building Electricity, Chilled Water, and Hot Water Consumption for Jack E. Brown Chemical Engineering Building during the Month of January 2016 and the Corresponding Hourly Outdoor Dry Bulb Temperature for College Station, TX

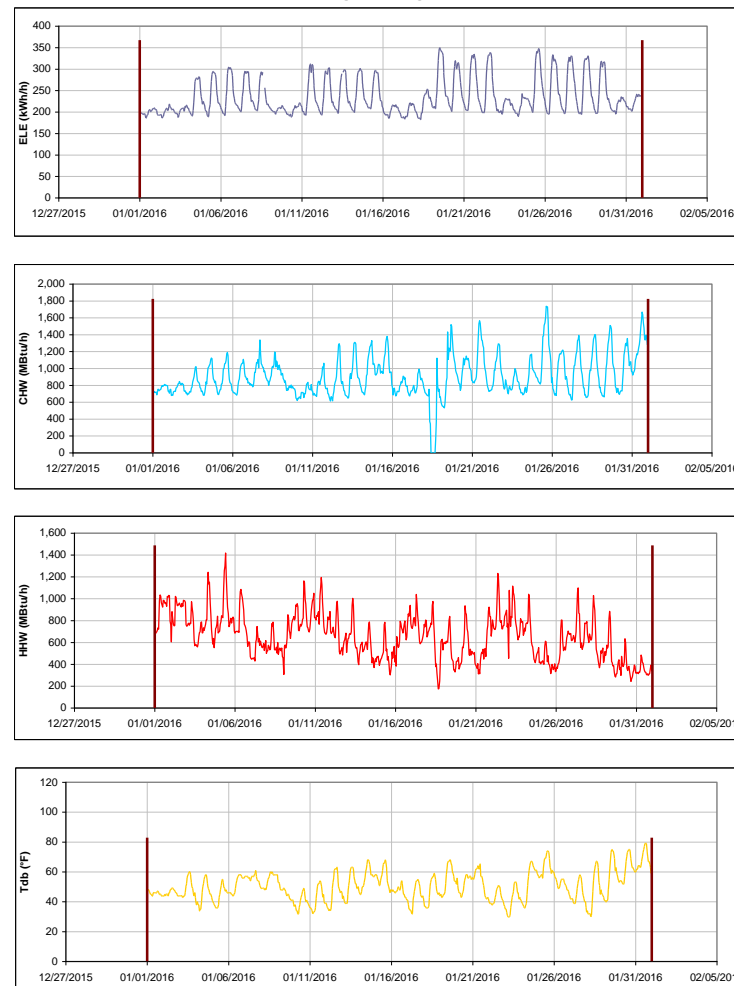
TAMU / BLDG #: 1391-0392

Figure III-22 Hourly Whole Building Electricity, Chilled Water, and Hot Water Consumption for James J. Cain'51 and Mechanical Engineering Office Building during the Month of January 2016 and the Corresponding Hourly Outdoor Dry Bulb Temperature for College Station, TX

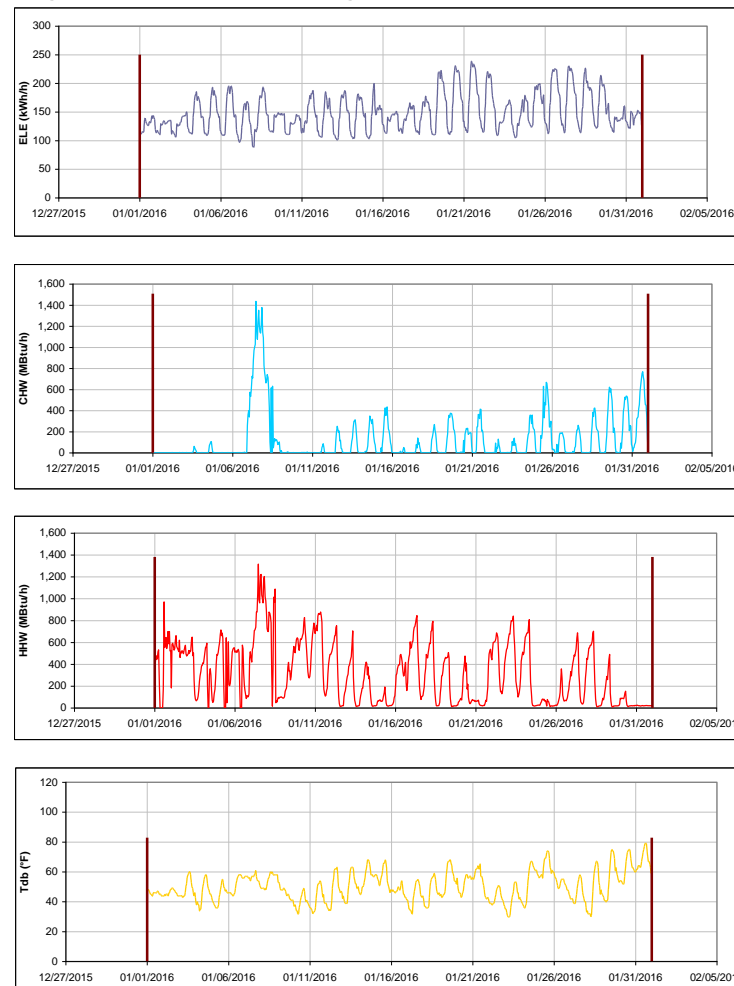
TAMU / BLDG #: 0398

Figure III-24 Hourly Whole Building Electricity, Chilled Water, and Hot Water Consumption for Langford Architecture Center Building A during the Month of January 2016 and the Corresponding Hourly Outdoor Dry Bulb Temperature for College Station, TX

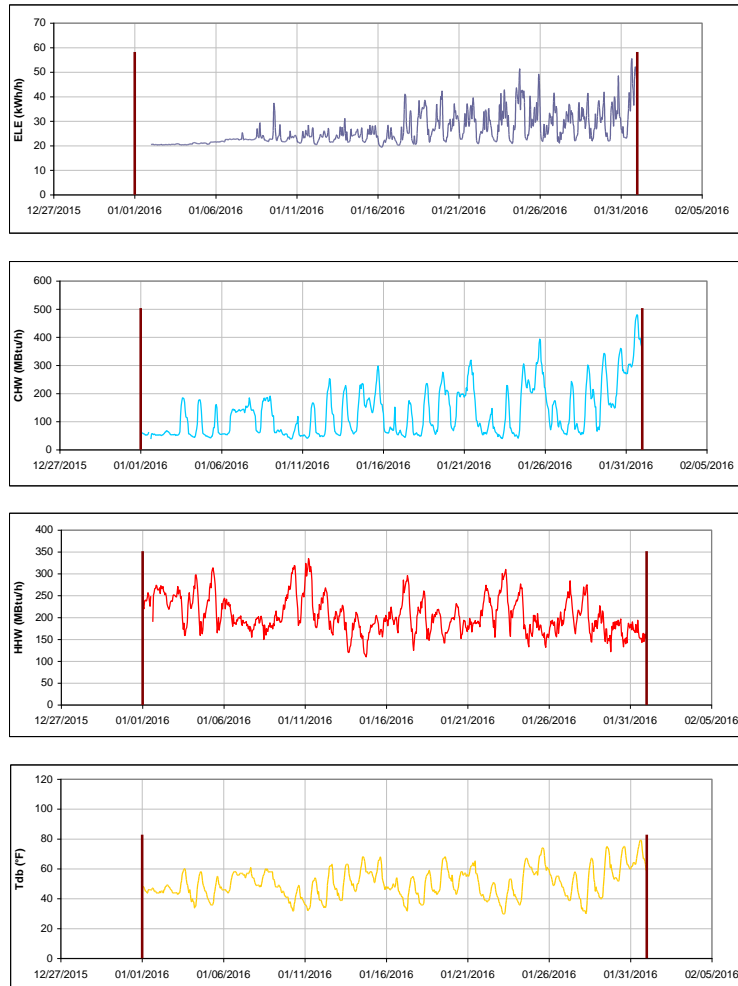
TAMU / BLDG #: 0405

Figure III-25 Hourly Whole Building Electricity, Chilled Water, and Hot Water Consumption for Lacy Hall - Dorm 6 during the Month of January 2016 and the Corresponding Hourly Outdoor Dry Bulb Temperature for College Station, TX

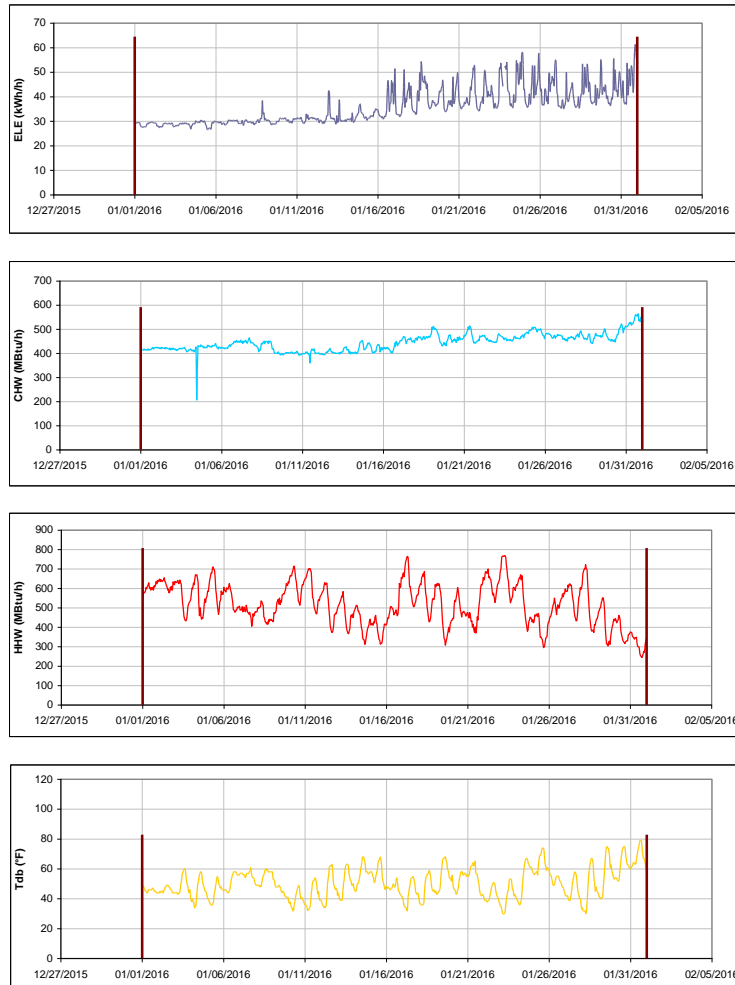
TAMU / BLDG #: 0415

Figure III-35 Hourly Whole Building Electricity, Chilled Water, and Hot Water Consumption for Davis-Gary Residence Hall during the Month of January 2016 and the Corresponding Hourly Outdoor Dry Bulb Temperature for College Station, TX

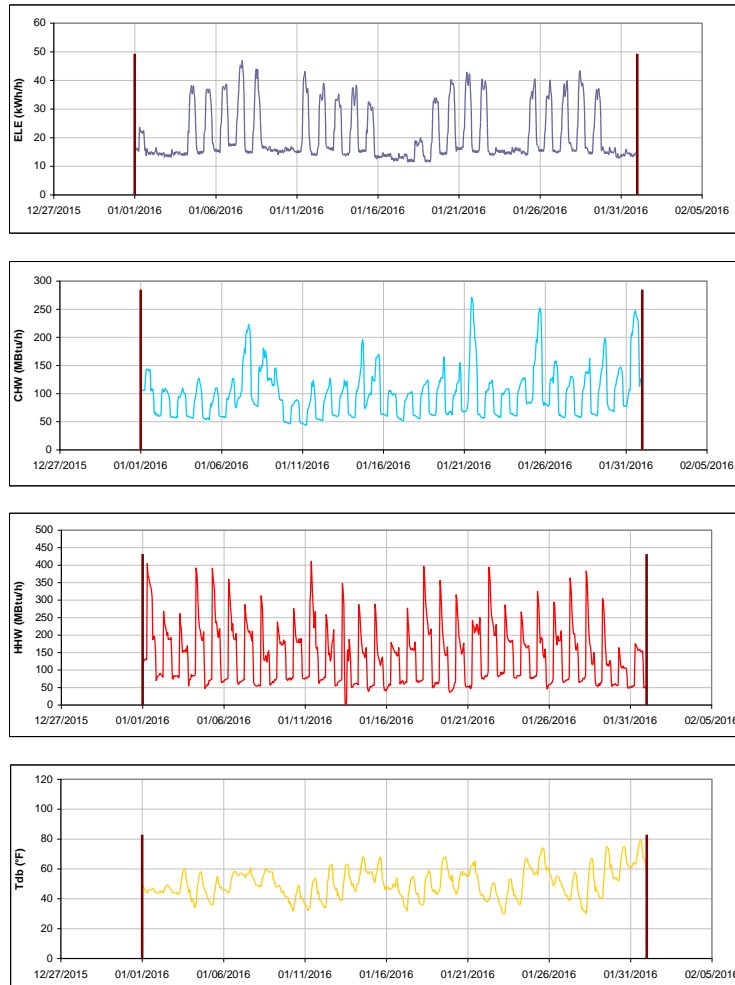
TAMU / BLDG #: 0425

Figure III-39 Hourly Whole Building Electricity, Chilled Water, and Hot Water Consumption for Henderson Hall during the Month of January 2016 and the Corresponding Hourly Outdoor Dry Bulb Temperature for College Station, TX

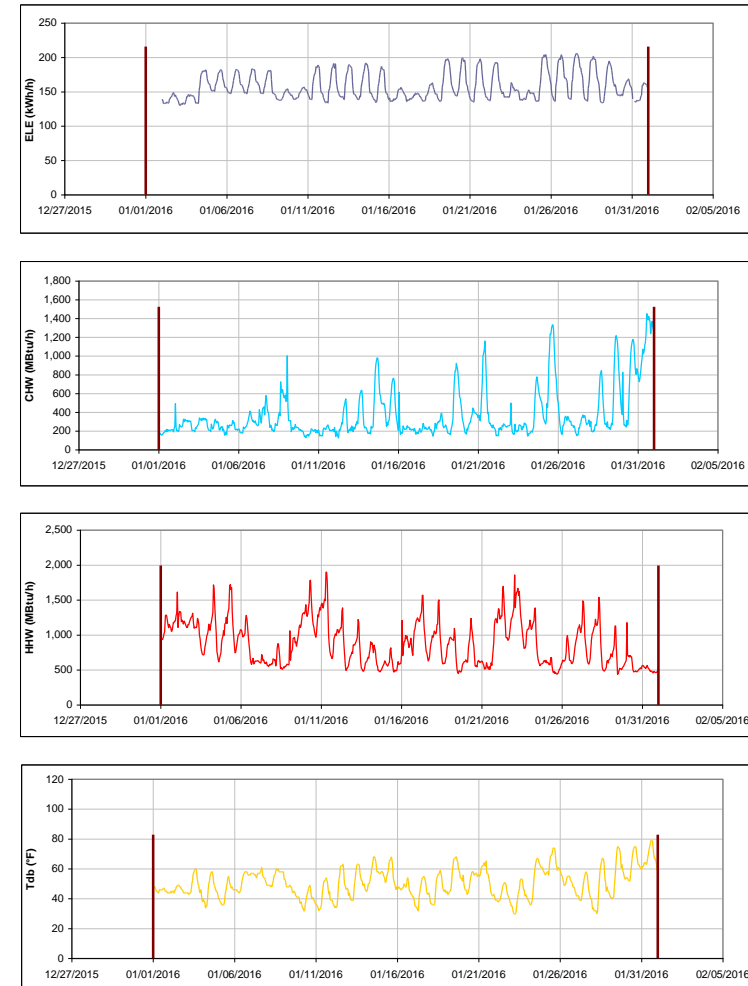
TAMU / BLDG #: 0436-0499

Figure III-48 Hourly Whole Building Electricity, Chilled Water, and Hot Water Consumption for Reed-McDonald and Engineering Innovation Center during the Month of January 2016 and the Corresponding Hourly Outdoor Dry Bulb Temperature for College Station, TX

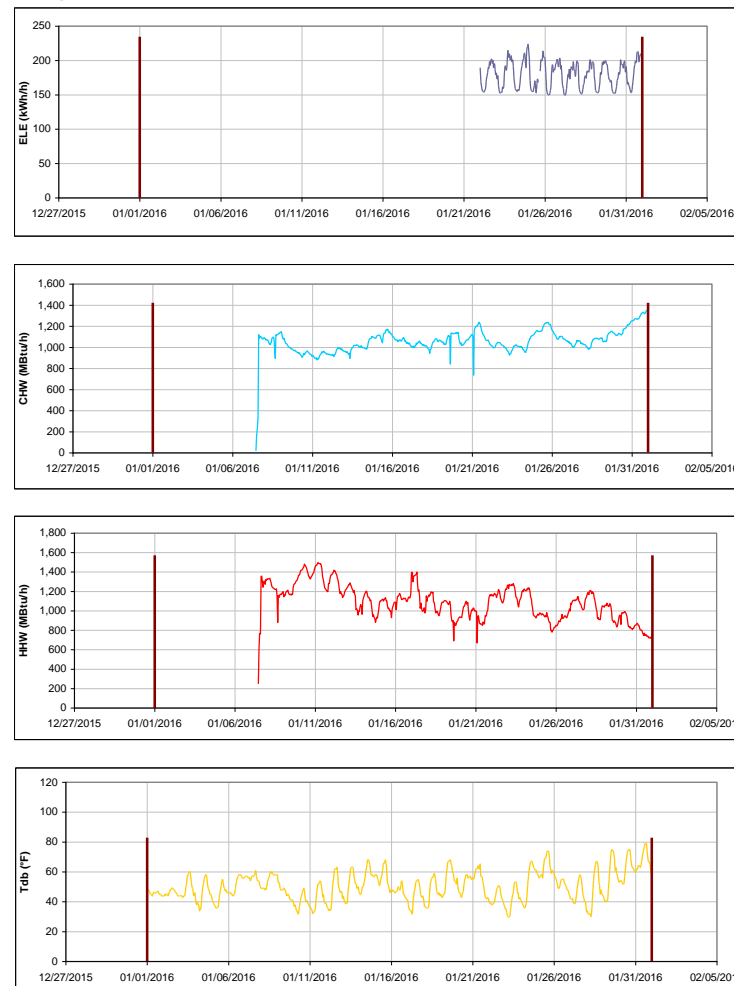
TAMU / BLDG #: 0441

Figure III-50 Hourly Whole Building Electricity, Chilled Water, and Hot Water Consumption for Krueger Residence Hall during the Month of January 2016 and the Corresponding Hourly Outdoor Dry Bulb Temperature for College Station, TX

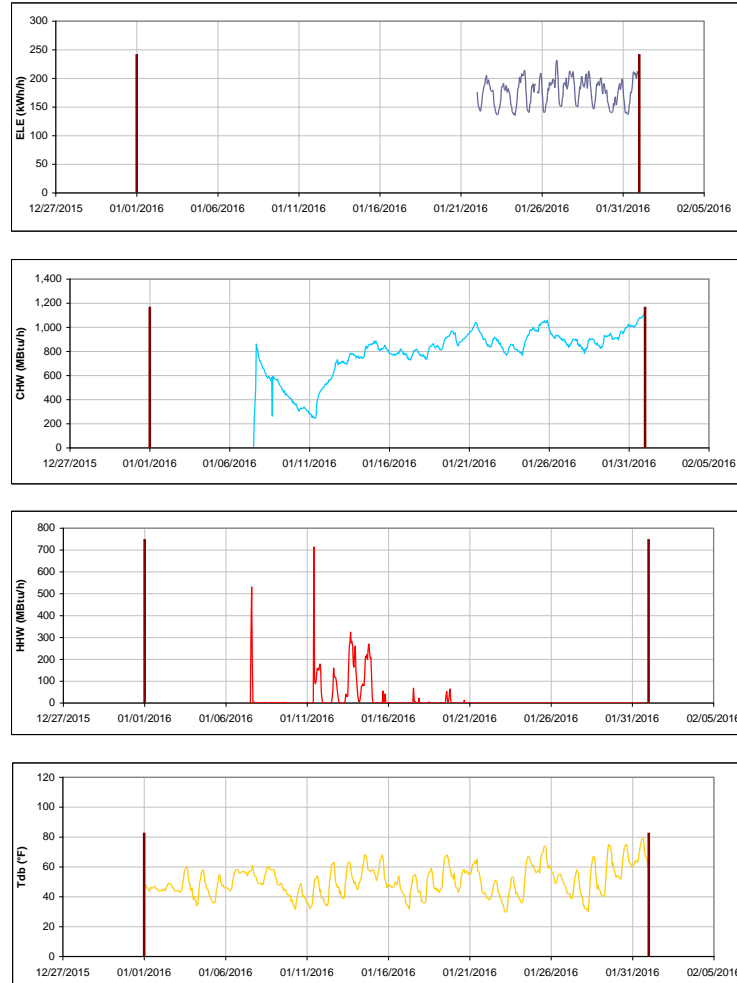
TAMU / BLDG #: 0442

Figure III-51 Hourly Whole Building Electricity, Chilled Water, and Hot Water Consumption for Dunn Residence Hall during the Month of January 2016 and the Corresponding Hourly Outdoor Dry Bulb Temperature for College Station, TX

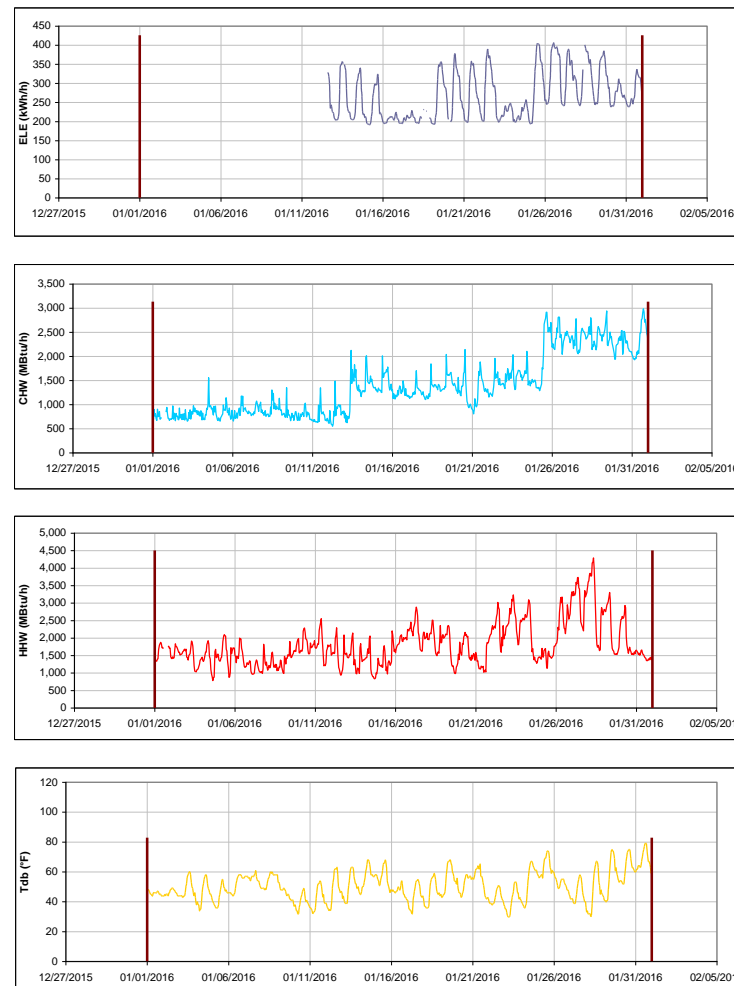
TAMU / BLDG #: 0446

Figure III-56 Hourly Whole Building Electricity, Chilled Water, and Hot Water Consumption for Rudder Tower and Theatre Complex during the Month of January 2016 and the Corresponding Hourly Outdoor Dry Bulb Temperature for College Station, TX

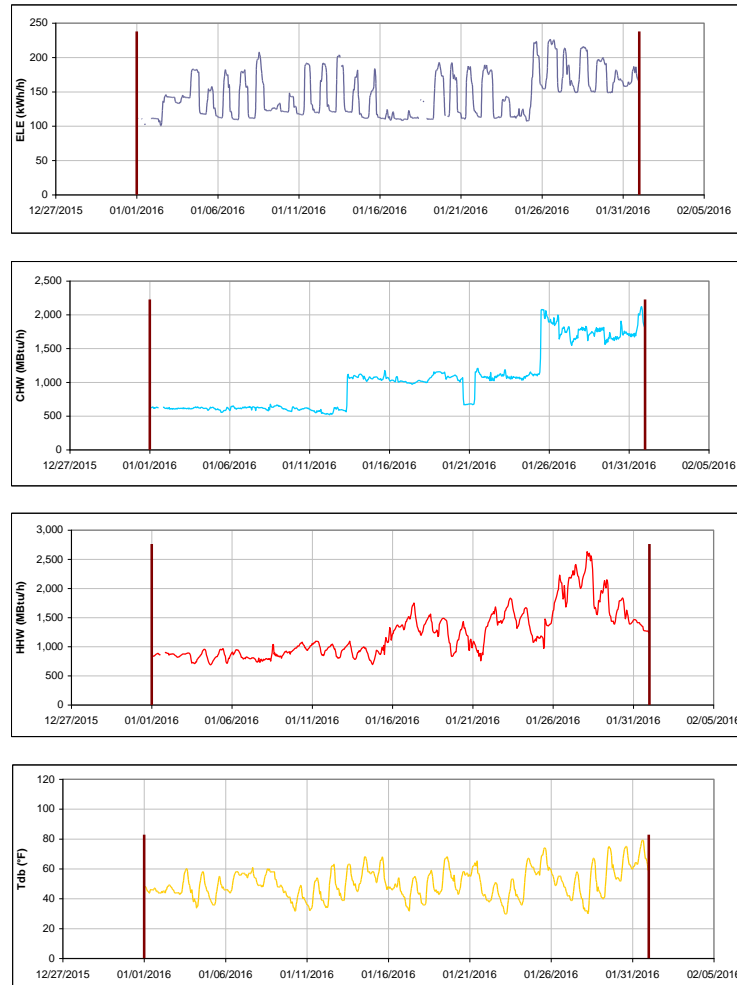
TAMU / BLDG #: 0446-A

Figure III-57 Hourly Whole Building Electricity, Chilled Water, and Hot Water Consumption for Rudder Theatre Complex during the Month of January 2016 and the Corresponding Hourly Outdoor Dry Bulb Temperature for College Station, TX

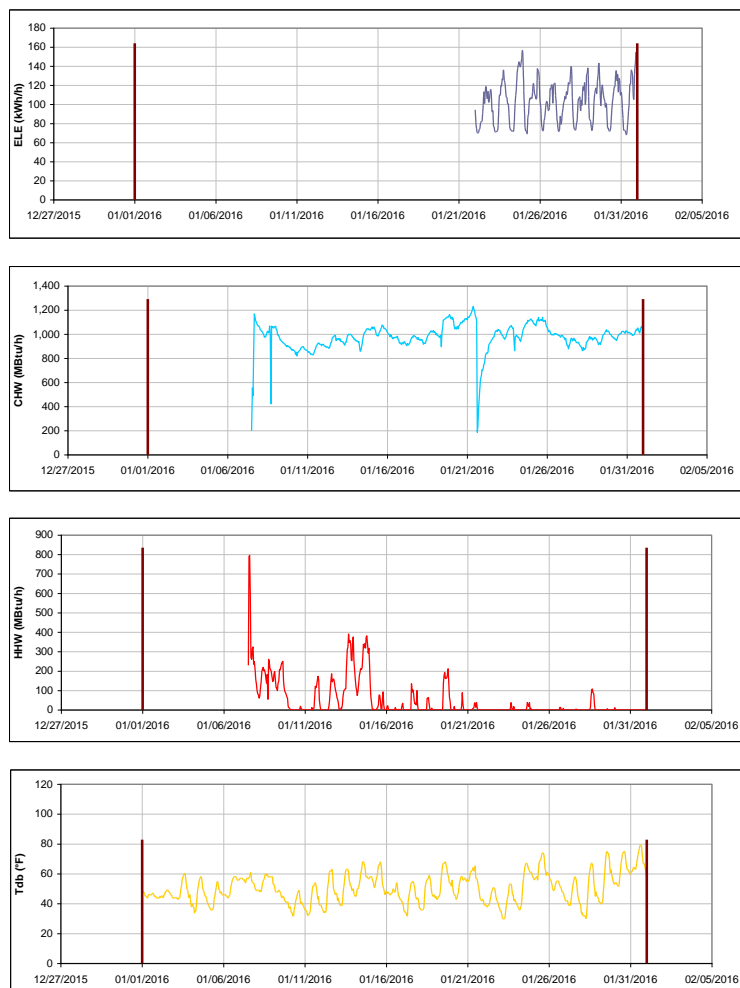
TAMU / BLDG #: 0447

Figure III-59 Hourly Whole Building Electricity, Chilled Water, and Hot Water Consumption for Aston Residence Hall during the Month of January 2016 and the Corresponding Hourly Outdoor Dry Bulb Temperature for College Station, TX

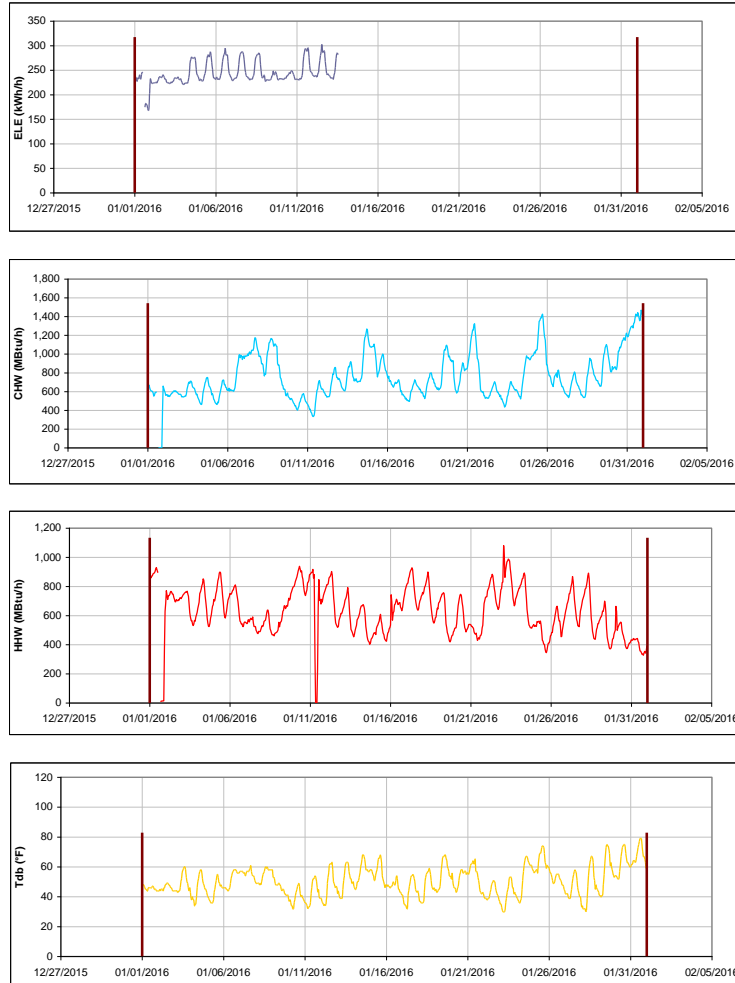
TAMU / BLDG #: 0449

Figure III-61 Hourly Whole Building Electricity, Chilled Water, and Hot Water Consumption for Biological Sciences Building - West during the Month of January 2016 and the Corresponding Hourly Outdoor Dry Bulb Temperature for College Station, TX

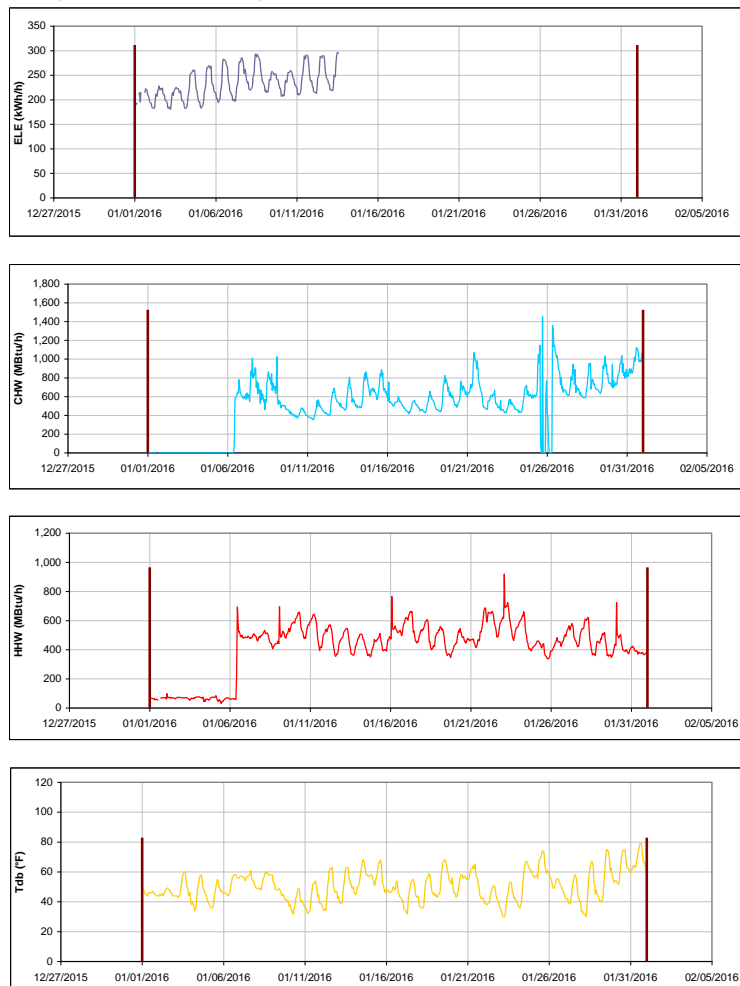
TAMU / BLDG #: 0467

Figure III-71 Hourly Whole Building Electricity, Chilled Water, and Hot Water Consumption for Biological Sciences Building - East during the Month of January 2016 and the Corresponding Hourly Outdoor Dry Bulb Temperature for College Station, TX

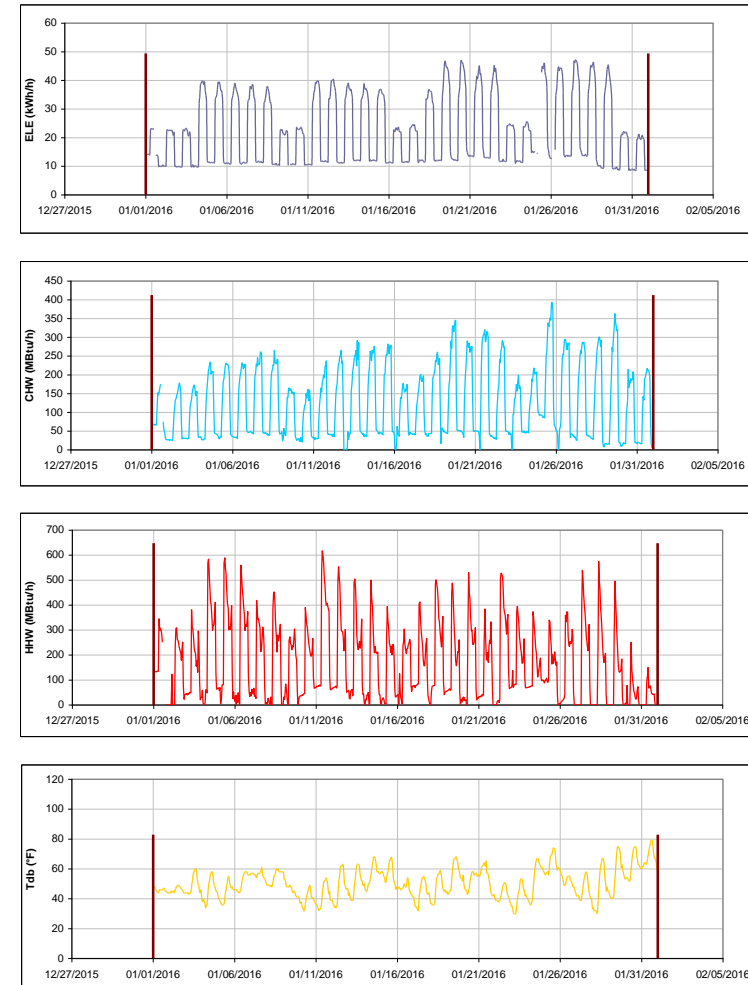
TAMU / BLDG #: 0470

Figure III-74 Hourly Whole Building Electricity, Chilled Water, and Hot Water Consumption for Glasscock History Bldg during the Month of January 2016 and the Corresponding Hourly Outdoor Dry Bulb Temperature for College Station, TX

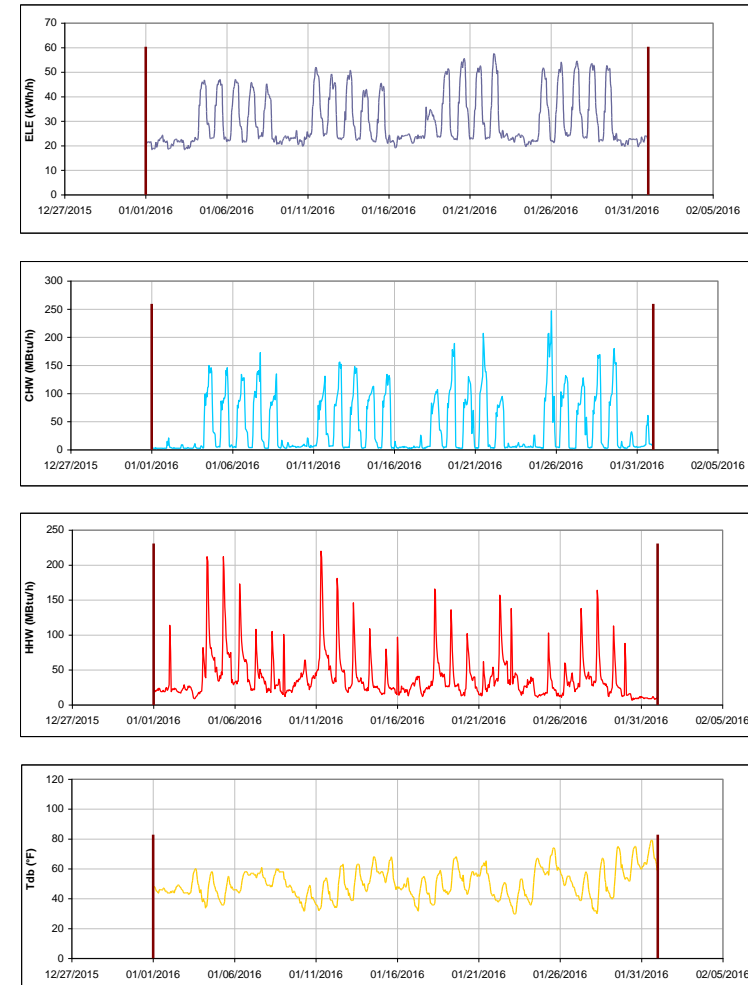
TAMU / BLDG #: 0474

Figure III-78 Hourly Whole Building Electricity, Chilled Water, and Hot Water Consumption for YMCA Building during the Month of January 2016 and the Corresponding Hourly Outdoor Dry Bulb Temperature for College Station, TX

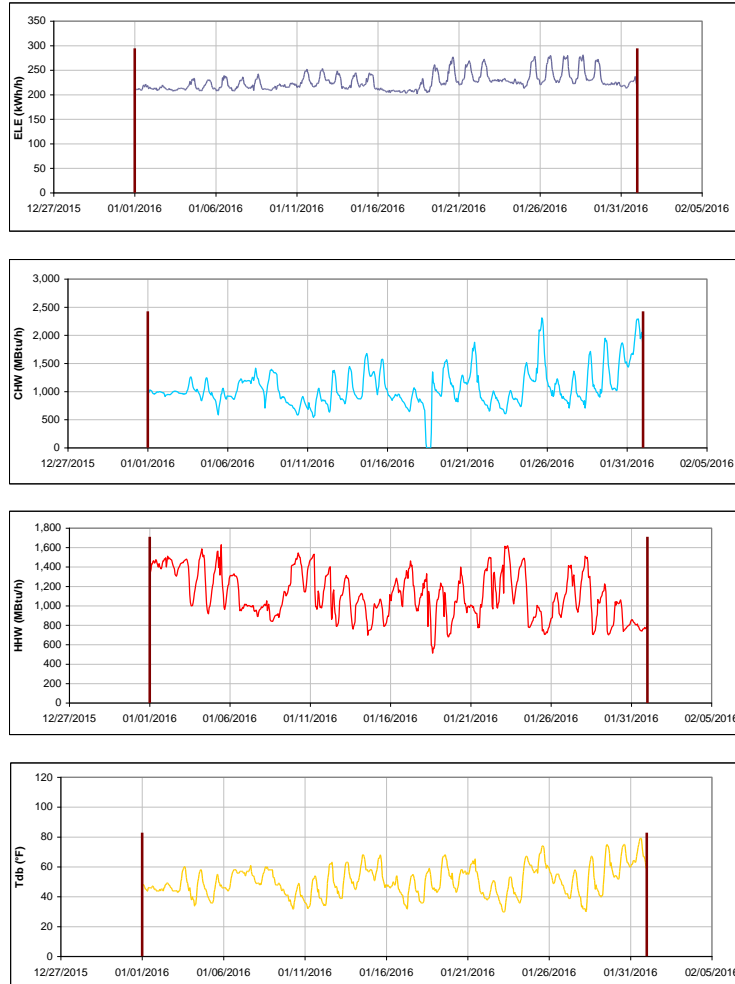
TAMU / BLDG #: 0490

Figure III-87 Hourly Whole Building Electricity, Chilled Water, and Hot Water Consumption for Halbouty Geosciences Building during the Month of January 2016 and the Corresponding Hourly Outdoor Dry Bulb Temperature for College Station, TX

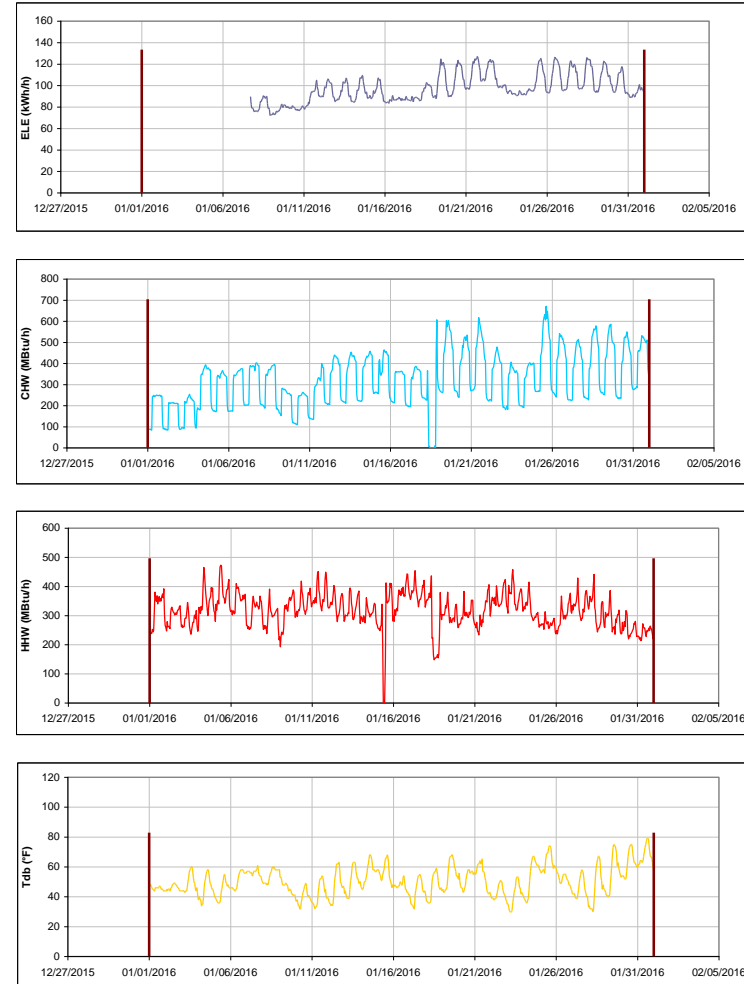
TAMU / BLDG #: 0492

Figure III-88 Hourly Whole Building Electricity, Chilled Water, and Hot Water Consumption for Civil Engineering Building during the Month of January 2016 and the Corresponding Hourly Outdoor Dry Bulb Temperature for College Station, TX

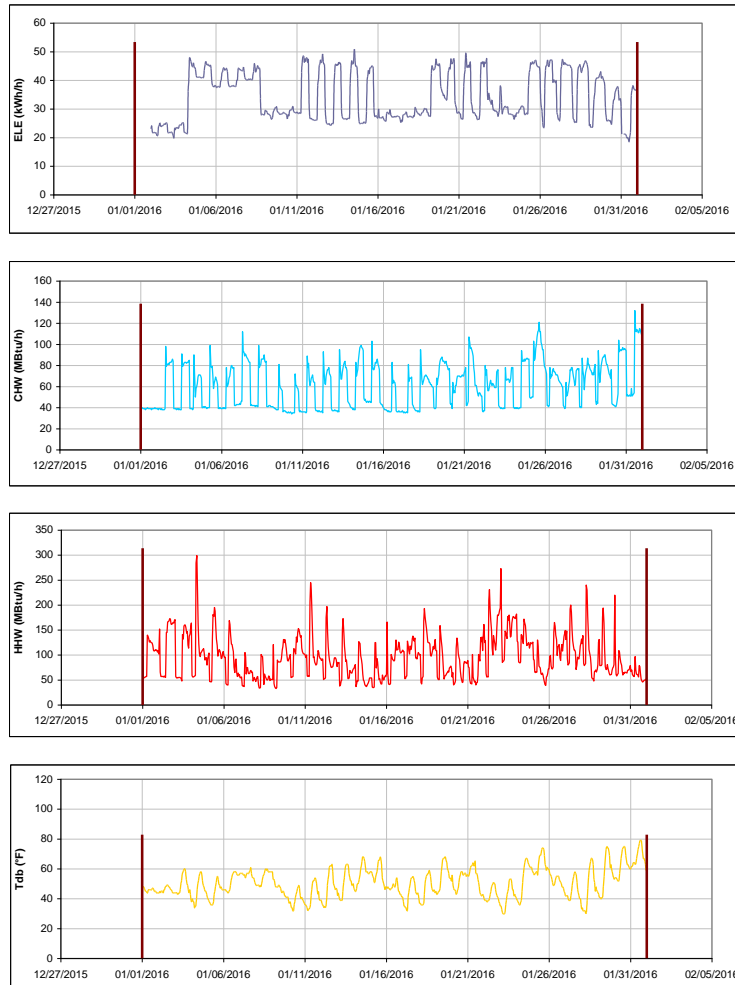
TAMU / BLDG #: 0499

Figure III-91 Hourly Whole Building Electricity, Chilled Water, and Hot Water Consumption for Engineering Innovation Center during the Month of January 2016 and the Corresponding Hourly Outdoor Dry Bulb Temperature for College Station, TX

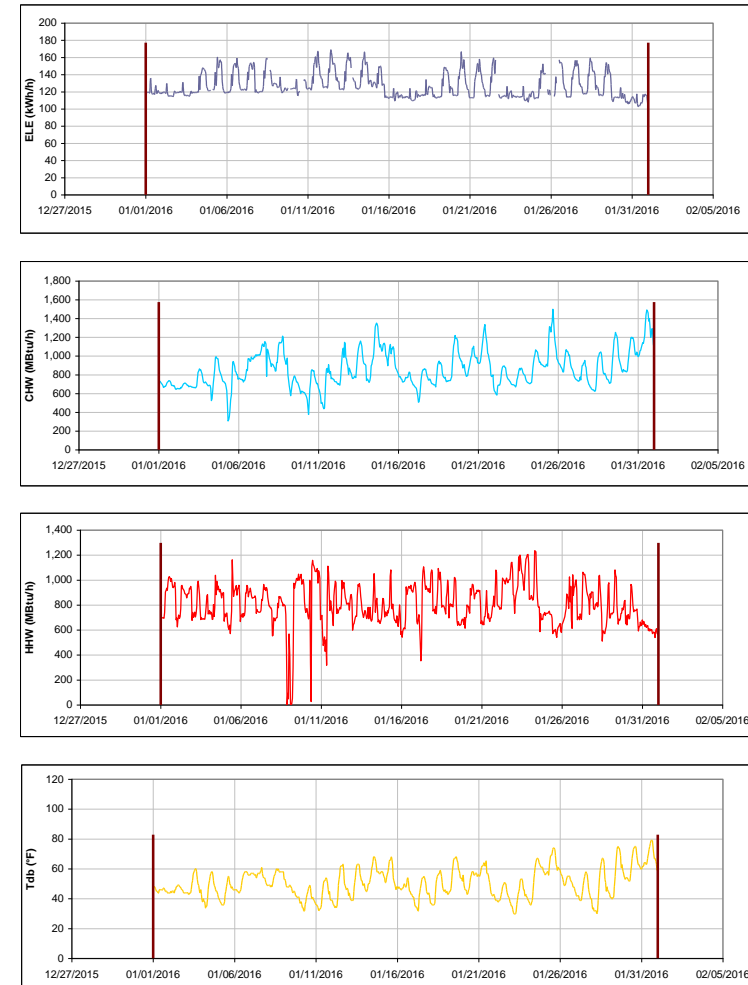
TAMU / BLDG #: 0507

Figure III-94 Hourly Whole Building Electricity, Chilled Water, and Hot Water Consumption for Veterinary Medical Science Building during the Month of January 2016 and the Corresponding Hourly Outdoor Dry Bulb Temperature for College Station, TX

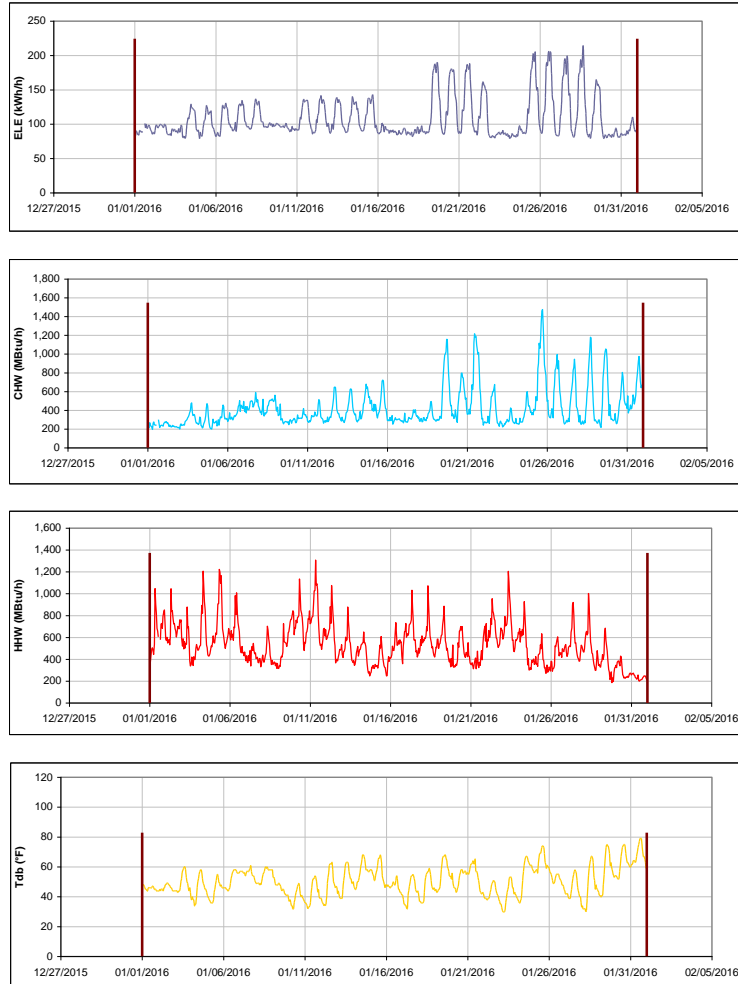
TAMU / BLDG #: 0521

Figure III-103 Hourly Whole Building Electricity, Chilled Water, and Hot Water Consumption for Heldenfels Hall during the Month of January 2016 and the Corresponding Hourly Outdoor Dry Bulb Temperature for College Station, TX

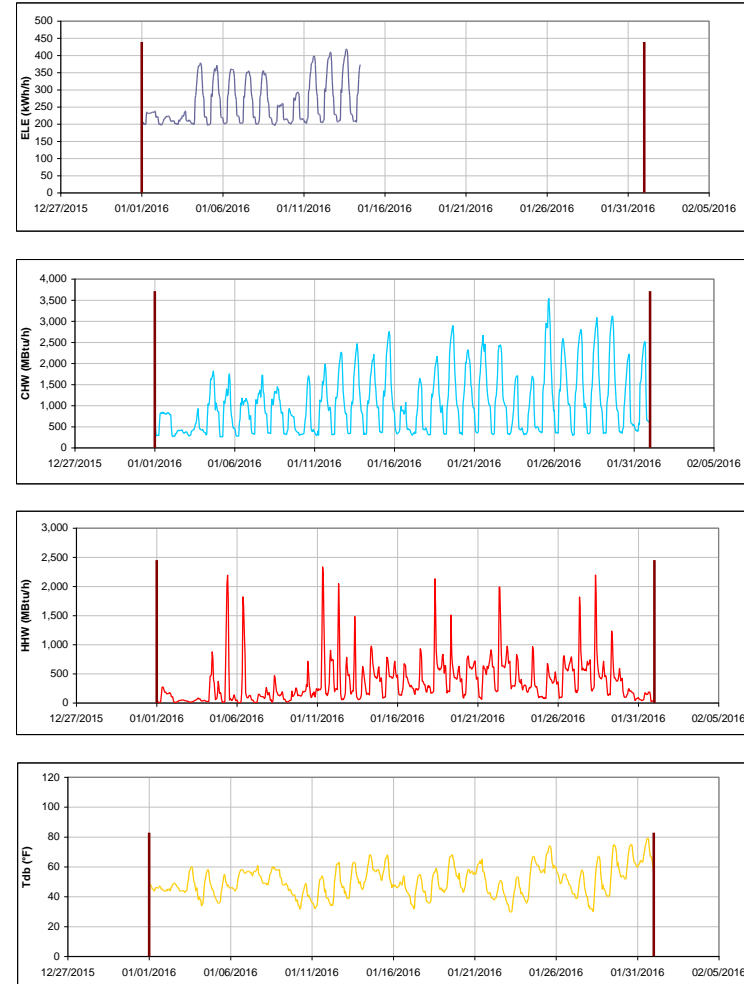
TAMU / BLDG #: 0524

Figure III-104 Hourly Whole Building Electricity, Chilled Water, and Hot Water Consumption for Blocker building during the Month of January 2016 and the Corresponding Hourly Outdoor Dry Bulb Temperature for College Station, TX

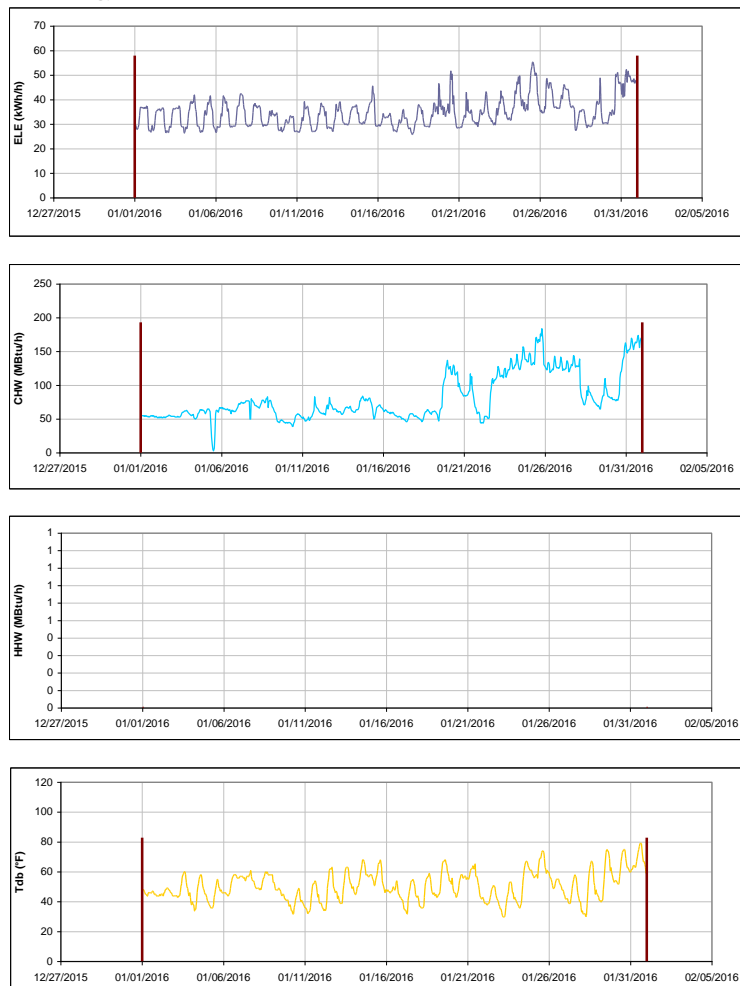
TAMU / BLDG #: 0815

Figure III-113 Hourly Whole Building Electricity, Chilled Water, and Hot Water Consumption for Entomology Research Lab during the Month of January 2016 and the Corresponding Hourly Outdoor Dry Bulb Temperature for College Station, TX

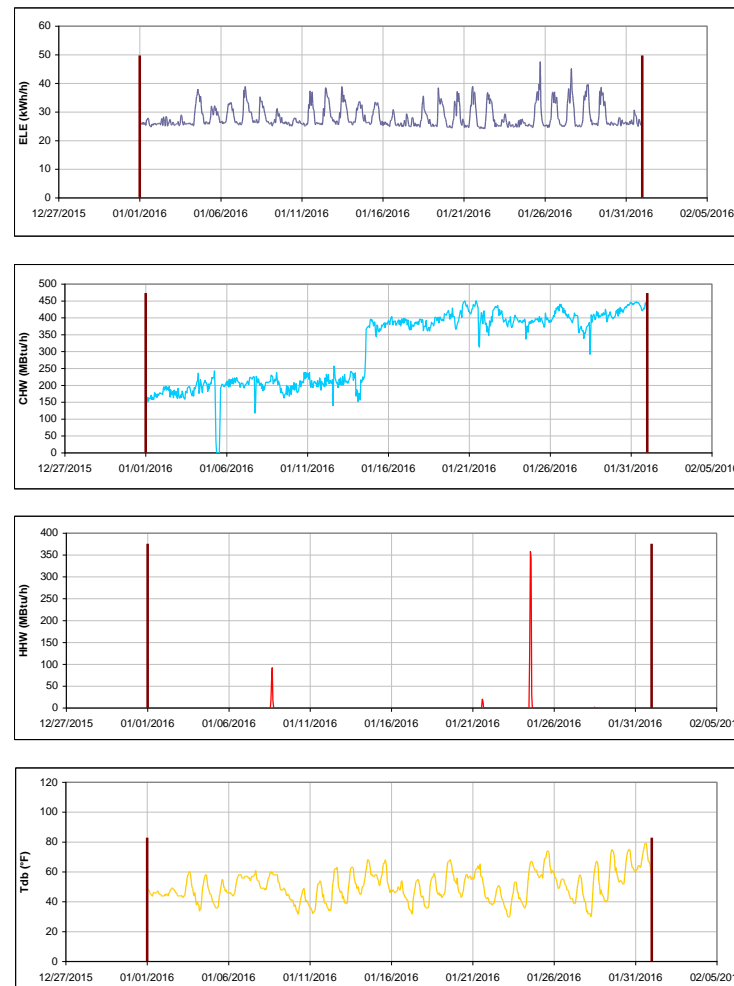
TAMU / BLDG #: 1020

Figure III-116 Hourly Whole Building Electricity, Chilled Water, and Hot Water Consumption for Vivarium III during the Month of January 2016 and the Corresponding Hourly Outdoor Dry Bulb Temperature for College Station, TX

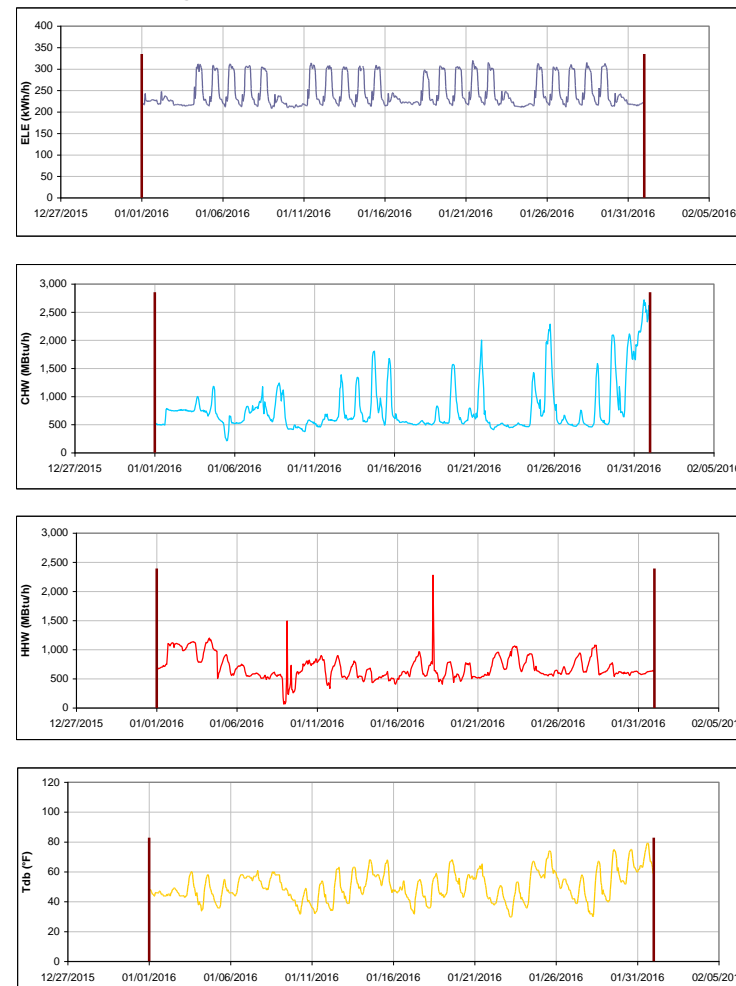
TAMU / BLDG #: 1041

Figure III-118 Hourly Whole Building Electricity, Chilled Water, and Hot Water Consumption for Texas Vet Med Diagnostic Lab during the Month of January 2016 and the Corresponding Hourly Outdoor Dry Bulb Temperature for College Station, TX

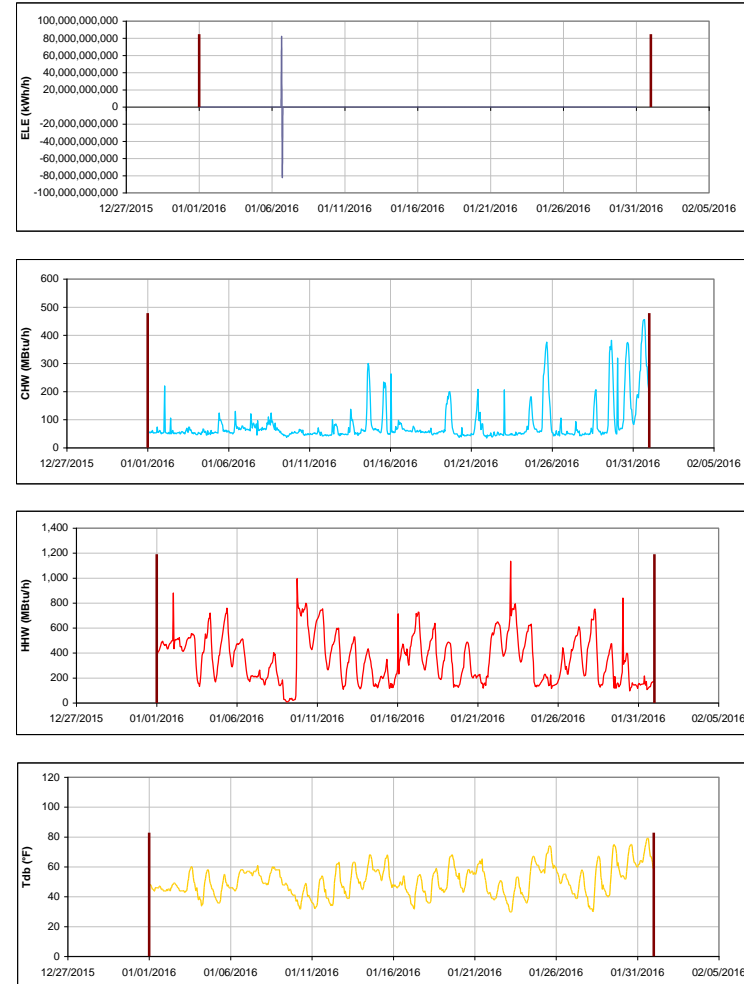
TAMU / BLDG #: 1184

Figure III-124 Hourly Whole Building Electricity, Chilled Water, and Hot Water Consumption for Veterinary Anatomic Pathology during the Month of January 2016 and the Corresponding Hourly Outdoor Dry Bulb Temperature for College Station, TX
